Analysis of Lighting Fixtures

MMR Project No. 82999

MassDOT
Boston, MA

April 5, 2011

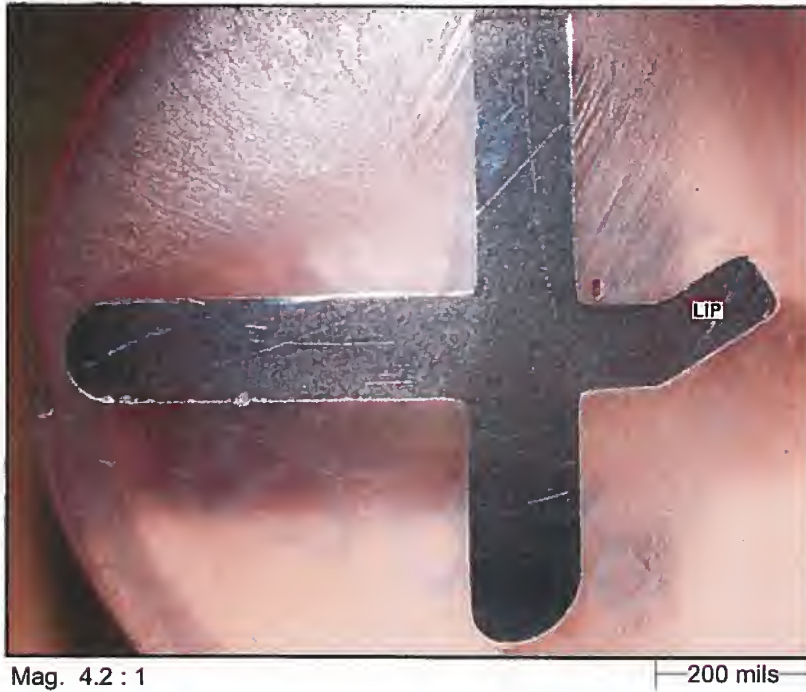
Representative overall stereomicroscopic views from different mounted locations are presented in Figures 26 – 35. Note that Mount 1-3, which is away from the clip engagement location, displayed only isolated areas of shallow corrosion at the lip area. Maximum depth of corrosion at this location was measured to be 0.003" for this mount.

Figure 26: Sample #1: Mount 1-3. This location is away from the clip. Overall view of the mounted cross-section. The clip is attached to the lip location.

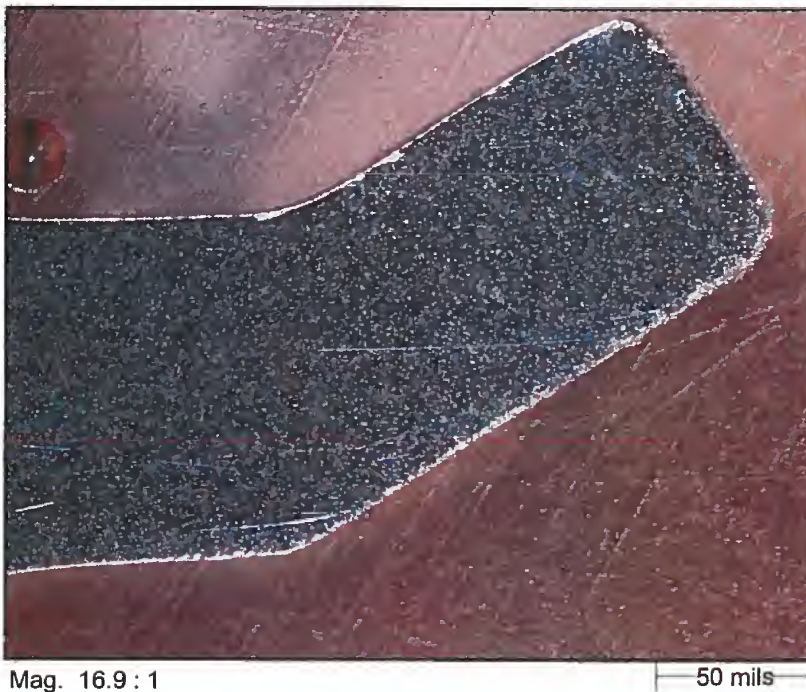
Figure 27: Sample #1: Mount 1-3. The clip is attached to the lip location.

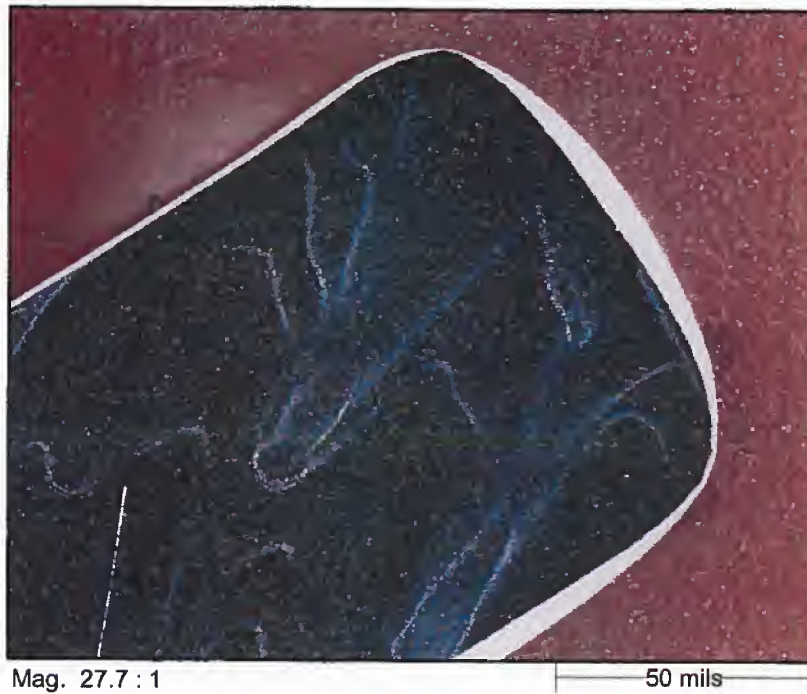
Figure 59: Sample #2: NuArt, new. Mount 2-2. A higher magnification view of the lip area. Note thin coating at the edges/corners.

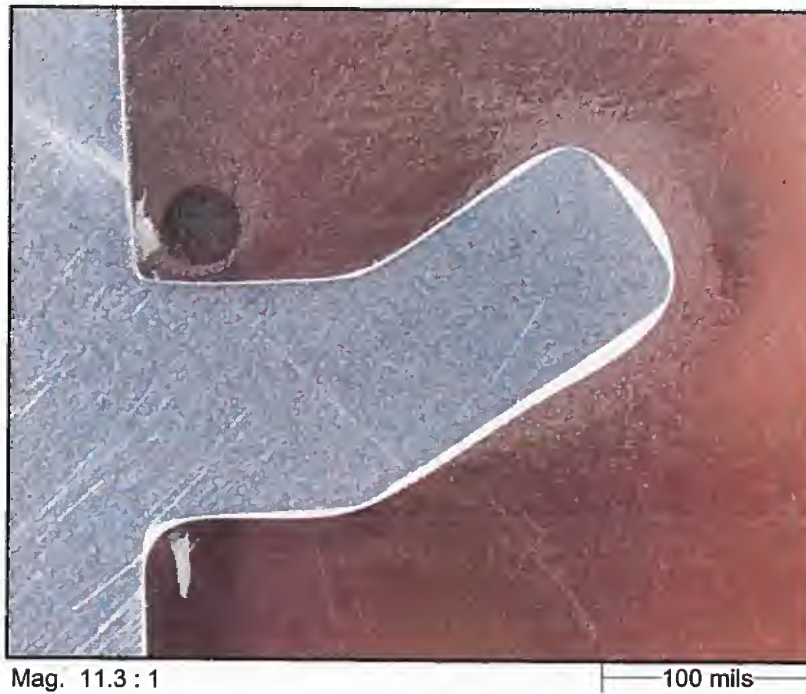
Figure 63: Sample #3: Mount 3-2. A close up view of the lip area.

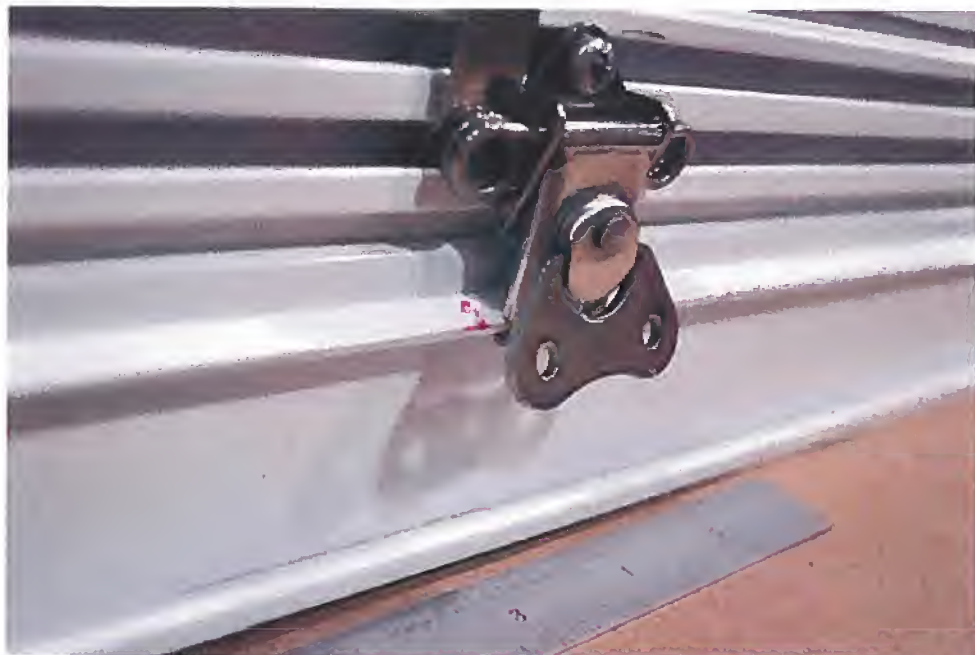
Figure 81: Sample #2 (NuArt): The same as in Figure 80 at an angled view showing attachment of a clip to the wireway lip.

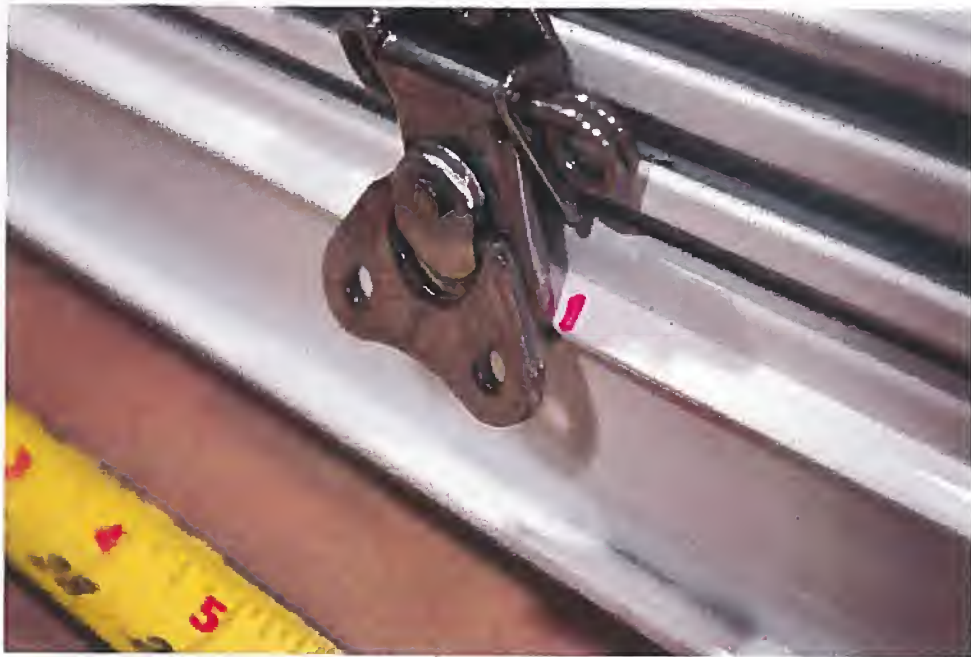
Figure 86: Sample #3 (Schreader): The same as in Figure 85 viewed from an angle to show the clip attachment to the lip area of the wireway.
